ACCESS PLATFORM

This case study highlights the key details of an engineering project completed at JB Engineering (Hatton) Ltd. The platform project was for a longstanding customer based within the manufacturing sector. The project was delivered on time and within the quoted price. Our BS EN1090 accreditation supported this structural manufacture with adherence to those standards throughout this project, ensuring our compliance and that of our customers with the Construction Products Regulation (CPR).

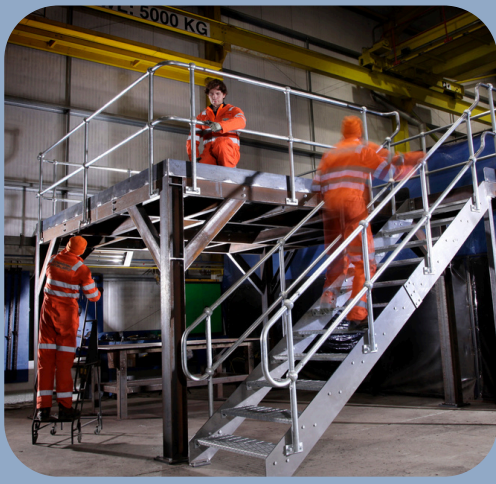
- During the galvanising process, the tread plate flooring experienced distortion as a result of thermal stress and material movement. This distortion manifested as buckling across the plate surface, altering its original flatness and dimensional stability. As a consequence of this deformation, the tread plate no longer aligned correctly with the pre-drilled fixing holes in the supporting platform structure. The positional shift created a mismatch between the hole centres, preventing straightforward installation and necessitating corrective action to achieve proper fit-up.
- During installation, the weight of the upper cross sections beams were deemed to be too heavy to safely lift without mechanical assistance.

- The tread plate flooring was mechanically restrained and clamped into position in order to counteract the bowing introduced during the galvanising process. Controlled clamping pressure was applied to progressively reduce the distortion and restore the plate as close as practicable to its intended profile and alignment with the supporting structure. Once the flooring had been adequately realigned, the fixing bolts were installed and tightened in a systematic sequence. This staged tightening process ensured that the plate was drawn evenly into its final position against the platform framework, minimising the risk of introducing further stress concentrations or secondary distortion while achieving secure and stable fixation.

- A PASMA scaffold tower was erected to provide access to the ceiling beams to allow a girder clamp and chain blocks to be fitted to assist lifting the platform steels into position.
